## TEST REPORT

Vibration Test

200500053TWN-001

Panel PC / LPC-P156WH-273

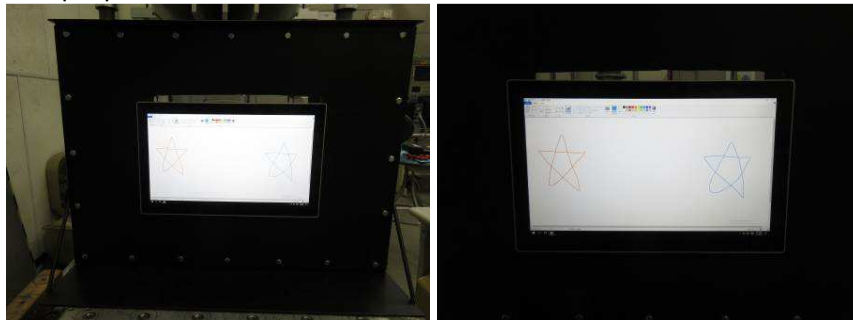
-Sample photo before the test:

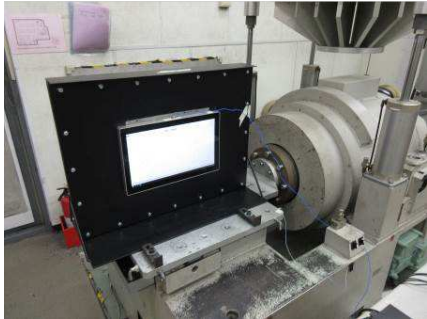
X axis

-Setup photo:  
Researching

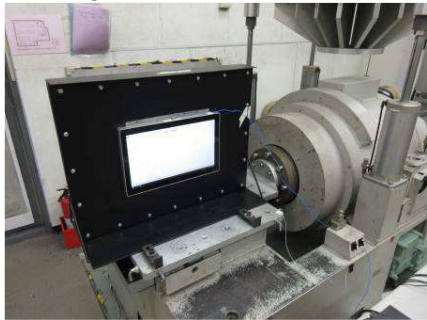
X axis

Dwelling

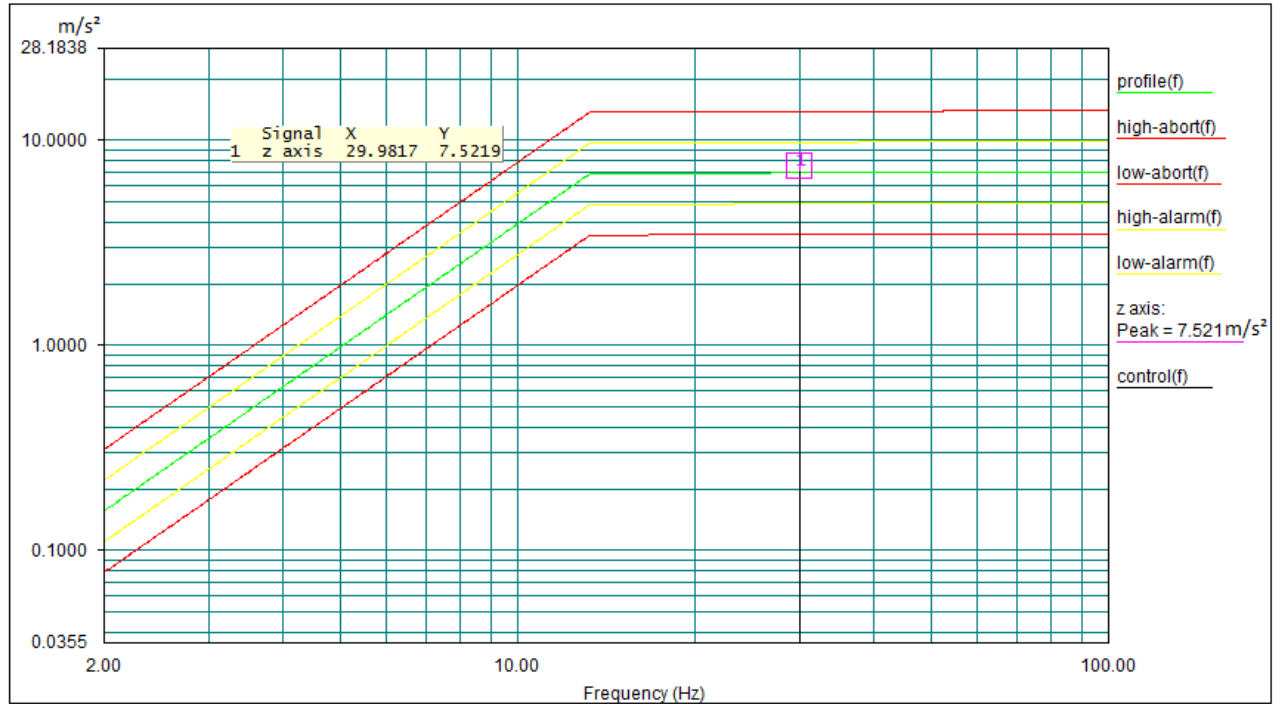
Z axis

Level: 100 %

Control Peak: 6.928245 m/s²

Full Level Time: 02:00:00

Sweep Rate: 1 Oct/Min

- Pulse Shape: Sine wave
- Operating (AC 230V): Input electrical power to operate during the test.
- Acceleration: 7 m/s<sup>2</sup>
- Duration: 120 minutes per frequency of resonance
- Direction: X, Y and Z axes
